GHAZIPUR LANDFILL REHABILITATION REPORT

East Delhi Municipal Corporation

SCS Engineers and Abt Associates

December 16, 2017

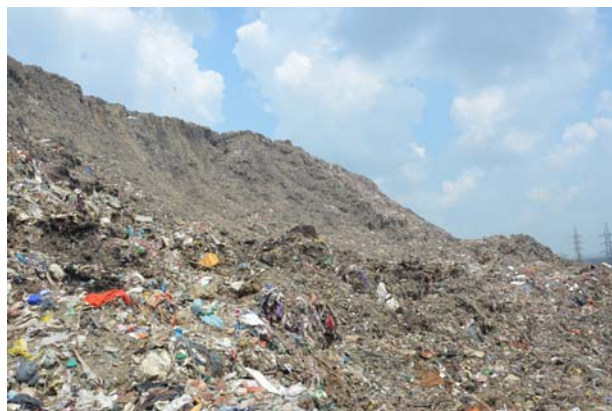
On September 1, 2017 a portion of the Ghazipur landfill's slope failed. Waste from the landfill slid 110 meters across an area adjacent to the landfill, including a road, the Hindon Canal, and the Escape Canal. As a result of this incident, two people died and five were injured. This incident spurred a renewed immediacy to improve operations and management at the Ghazipur landfill, explore alternative waste management options, and identify future landfill sites. The EDMC and its counterparts including the other Delhi municipal corporations, the Delhi Development Authority, and National Highways Authority are required to complete a series of actions. These action call for the EDMC and partners to develop action plans for waste management, begin bio-stabilization and compaction activities, begin waste segregation activities, identify new landfill sites, revisit environmental management practices, inspect augmenting the capacity of existing waste-to-energy (WTE) plants, develop new WTE plants, and create a pilot project using waste as a component of embankment filling at a nearby national highway (NGT, 2017a,b,c).

Ghazipur landfill slope failure (EDMC)

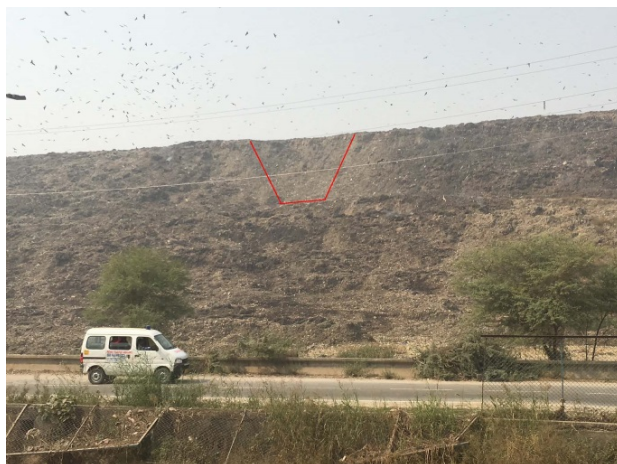
The September 1, 2017 slope failure started from high up on the central portion of the southeast slope. EDMC reported that the slide area measured 45 m wide at the crest, extended 50 m down the slope, was approximately 3 m deep, and represented a waste volume of about 7,000 m³. The failure occurred in an area where the slope ratio was estimated to be approximately 1:1.9 (about 28 degrees) and which is considered very steep for a landfill. The slope failure displaced a large mass of waste that moved downhill, flowed over the lower slope and into the adjacent drainage ditch, public roadway, and canal.

The slope failure occurred after a few days of continuous rain. Heavy rain events, in combination with steep slopes, poorly compacted waste, inadequate leachate management are well established as leading mechanisms to landfill slope failures. The role of wet, heavy waste in causing the slope failure was less evident two months later at the time of the November 1 site visit. As shown in the site visit photos, leachate seeps could be observed at the toe of the southeast slope below the slide area, but not on the upper or middle slopes in the vicinity of the slide.

Although seasonally high moisture conditions and a heavy rainstorm are key factors in the timing of the slide event, the fundamental causes of the slope failure are related to the steep slopes and poor waste management operations. Poor management of delivered waste and the lack of proper waste placement and compaction result in a weak and compressible waste mass that is prone to instability in areas with steep slopes. Delivered waste typically is unloaded at the high point of the waste mound and pushed by a single bulldozer into lifts (small mounds). Disposal practices at dump sites often include dumping or pushing waste off of the top deck onto the upper side slopes. These waste handling practices create steep side slopes consisting of loose, uncompacted waste with a low shear strength (measure of its cohesion), which increases the likelihood of instability.

September 1, 2017 slope failure location in upper east slope
(viewing west across from the canal)

Since the slope failure, EDMC started forming terraces or benches along the southeast slope to moderate the slopes. Benching is a common waste industry practice to decrease the effective slope ratio and improve slope stability. In general, benches at least 5 m wide should be installed on side slopes for every 10-15 m of elevation change. Such efforts should continue at least until the slope ratio is less than 1:2.7 overall, which is needed to achieve a preliminary FS value of at least 1.3. Further studies should be performed to more accurately establish the minimum acceptable FS value and thus the maximum slope.

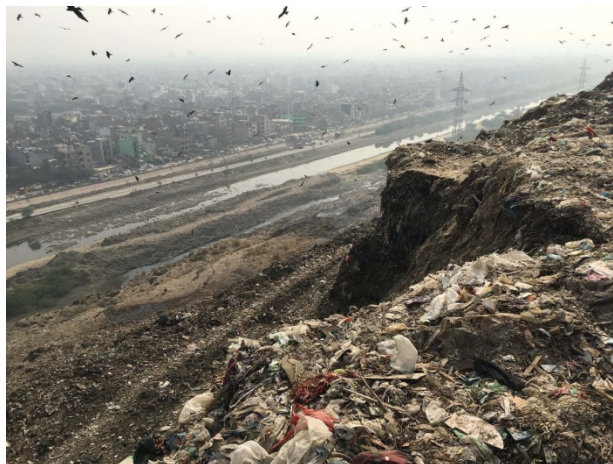
Slope failure site after canal clean-up
(viewing southeast on top of dump)

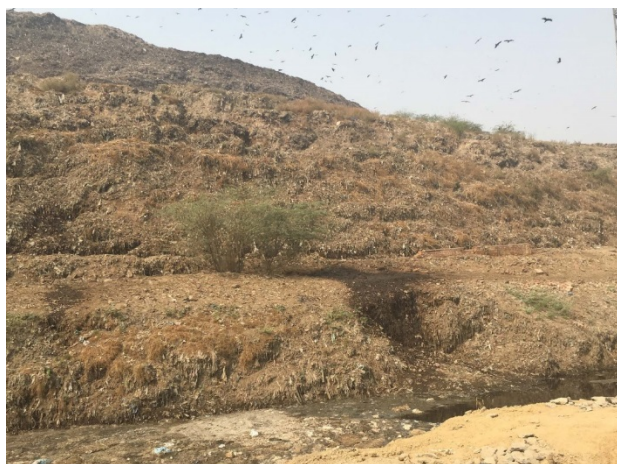
Leachate seeps on east side slope

- Conduct regular monitoring of liquid levels within the waste mass to identify zones where a build-up of liquids could lead to slope instability. The lack of soil cover and the practice of applying leachate to the active disposal area will contribute to elevated liquid levels and increased slope instability, particularly during the rainy season. Leachate application should be curtailed or stopped, or moved at least 30 m away from any side slopes.

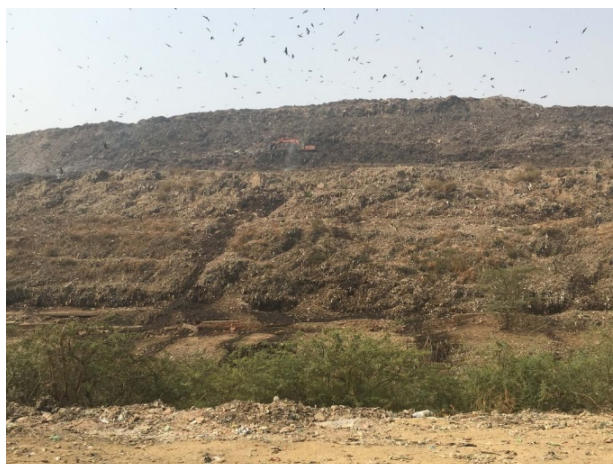
Leachate seepage and erosion rills on east side slope

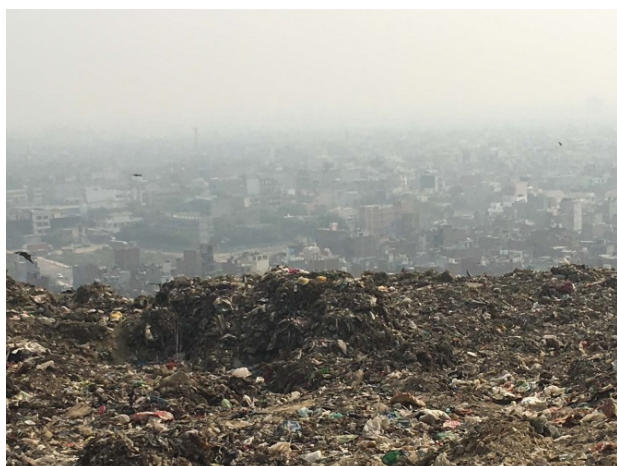
- **Site operations do not include proper placement and compaction of waste** – The waste is currently spread daily over a wide area of operation, insufficiently compacted due to lack of proper compaction equipment, and exposed to the elements. These factors increase the risk of future landfill fires and slope failures.
- **Symptoms of potential future slope failures exist** – A tension crack with a noticeable vertical drop of about 1 meter was observed in the same crest where the recent slope failure occurred. Its width is about 0.5 m and its length is almost 60 m. The waste surface is comprised of loose material and no soil cover. Due to the tension crack, the steepness of the landfill side slope, and

Uncompacted and uncovered waste

- Cease placing waste at the top of the landfill, which increases the instability of the steep slopes.
- Grade all flat waste surfaces to slopes of at least 5% to promote positive surface runoff and minimize water infiltration during rainy seasons.
- Apply a soil cover on side slopes of at least 0.3 m, which lowers infiltration from rainfall, enhances surface stability, and limits air intrusion that can contribute to landfill fires. Promoting vegetative growth on the soil cover will help to reduce erosion and therefore effectiveness of the soil cover.
- Improve waste compaction, which helps to stabilize the waste by increasing its shear strength and reducing its compressibility. This can be accomplished with a compactor designed for landfill applications, or other heavy equipment, provided that the waste is placed and compacted in thin lifts.

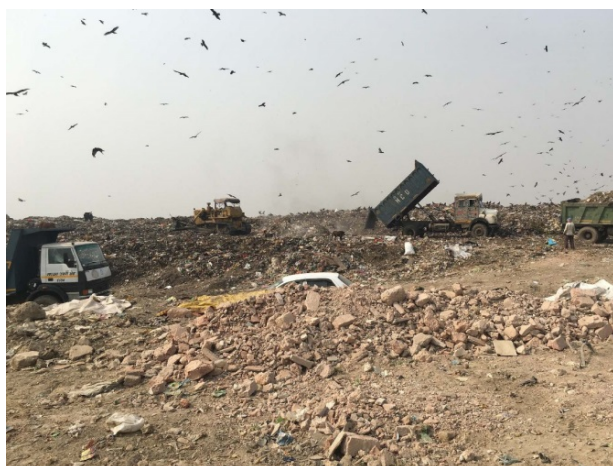
Waste filling on top of dumpsite

- **Stop disposing waste at the top** – Waste filling at the top of the landfill should cease immediately as it could further compromise slope stability.

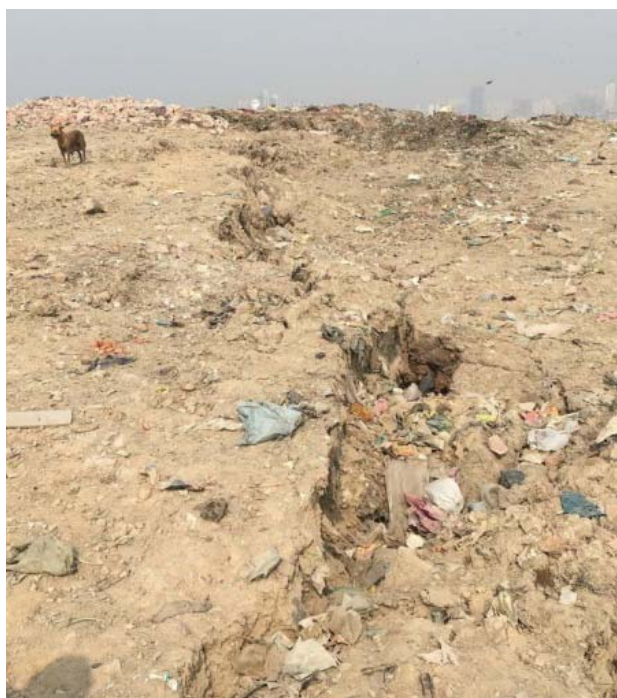
The potential risk of another slope failure on the upper southeast slope remains high while the FS is close to 1.0. On September 11, 2017, a new tension crack was observed to have formed at the crest of the southeast slope, just above the location of the slope failure. During the site visit on November 1, the tension crack was observed to be about 50-60 m long, 1 m deep, and 0.3-0.5 m wide (see photos). The tension crack was located about 5 m from the crest of the slope. The development of tension cracks in this location is an indicator of increased potential for future slope failure.

New tension crack near crest of east slope
(viewing north)

- Regularly inspect areas with steep slopes for tension cracks, deformation, or rapid settlement, which indicate an increased likelihood of slope failure.

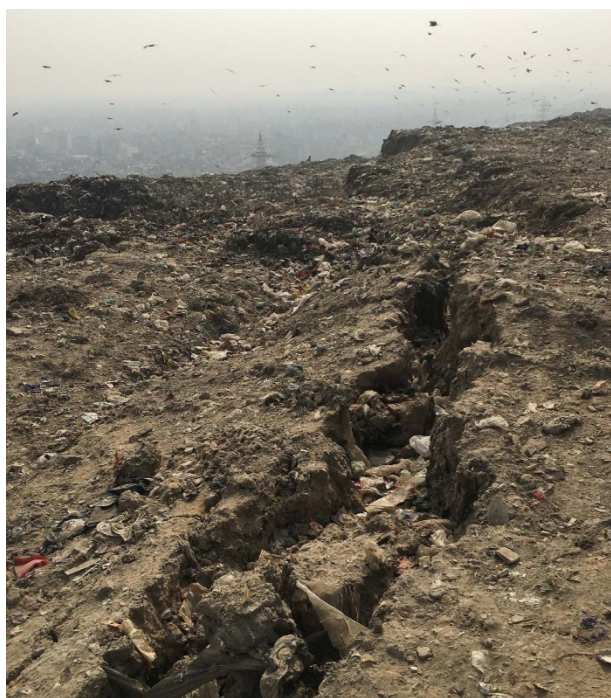
New tension crack near crest of east slope
(viewing south)

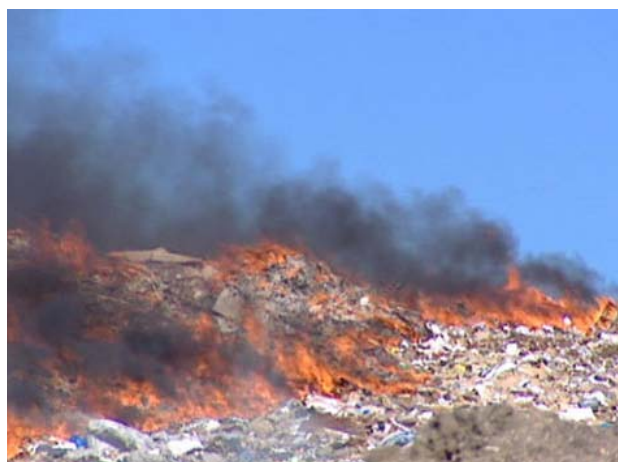
Surface fires are caused by “hot loads”, equipment, people smoking onsite, and by waste recyclers. Hot loads in this context refers to waste that catches fire, smolders, or spontaneously combusts, and could include brush, leaves, construction debris, fuel, tires or chemicals that could react and cause a fire. Causes of equipment related fires include debris trapped under machines, heat from equipment (exhaust pipes), and welding. Fires are also set by recyclers to reclaim metals.

Surface fire

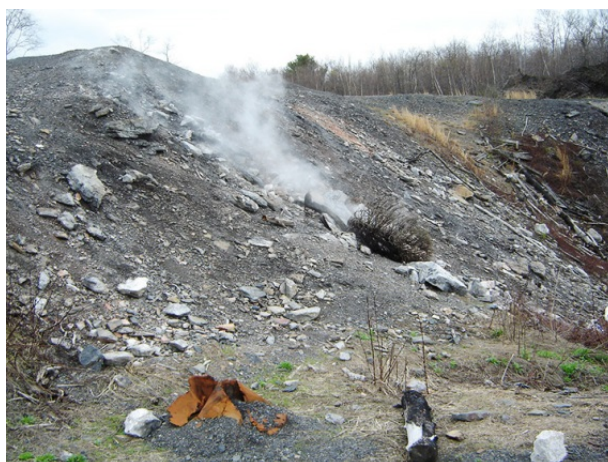
Subsurface fires result from air filtration into the waste mass. Both the waste in place and methane generated in the landfill are fuel sources; heat is generated by the microbial activity in the decomposing waste. Since the fire is below the surface, it is difficult to detect, gauge extent, and extinguish. Some of the visual indications of subsurface fires include sudden subsidence and depressions, fissures and cracks, venting holes and rills, and smoke.

Subsurface fire

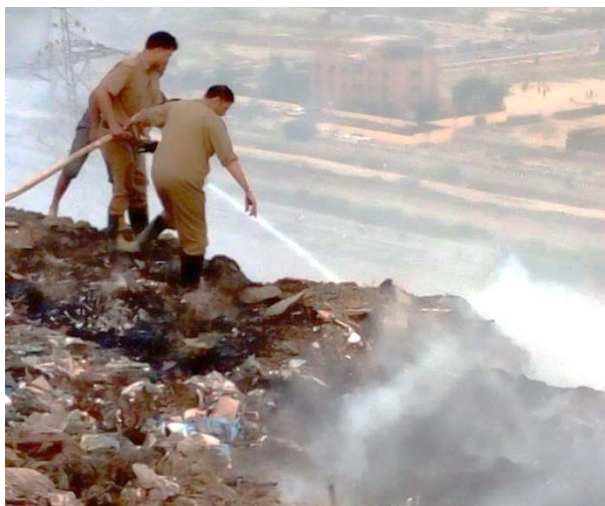
Addressing a fire at Ghazipur landfill (EDMC)

- The use of water to manage fires contributes to slope instability and should be avoided if possible. Instead of water, consider using foams and suppressants. Although this option may be expensive, it is very effective, especially for small areas. Alternatively, manufactured daily cover materials can be applied to side slopes to provide a surface that is resistant to water infiltration and that minimizes oxygen intrusion into the waste mass.

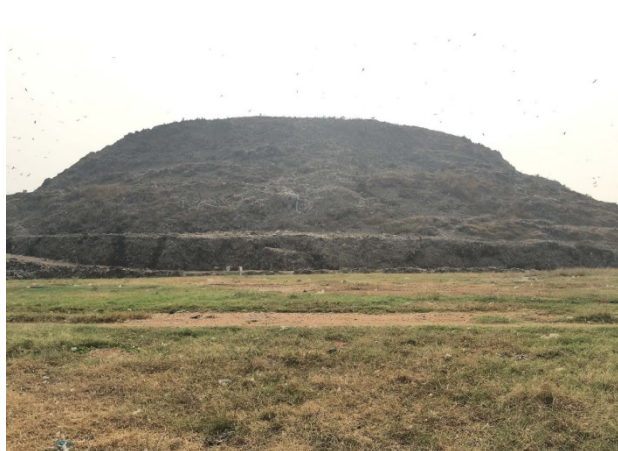
Closed area north of north slope (GAIL plant)

- Evaluate the suitability of moving waste disposal operations to two areas with potential air space. The first area is the closed north plateau, which is currently being used for landfill gas capture (see photos). The evaluation would examine the settling of the cap system, the stability of the closed side slope, and the area's safety and stability for further waste disposal. The use of this area would require an agreement with the landfill gas system operator (GAIL) before deciding whether the gas collection system could accommodate waste disposal, or whether it should be decommissioned, which would allow the removal of the final cover ("cap") and make space for additional waste. The second possible area for waste disposal is the triangle-shaped area at the south end of the site. This solution also needs further evaluation and consultation with the WTE plant operator.

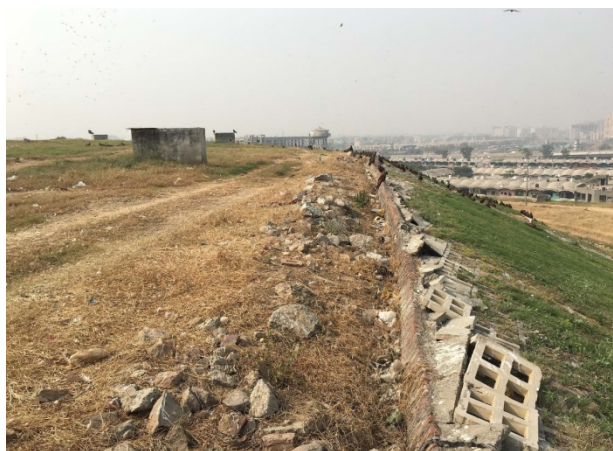
Settlement and lateral movement in north slope closed area

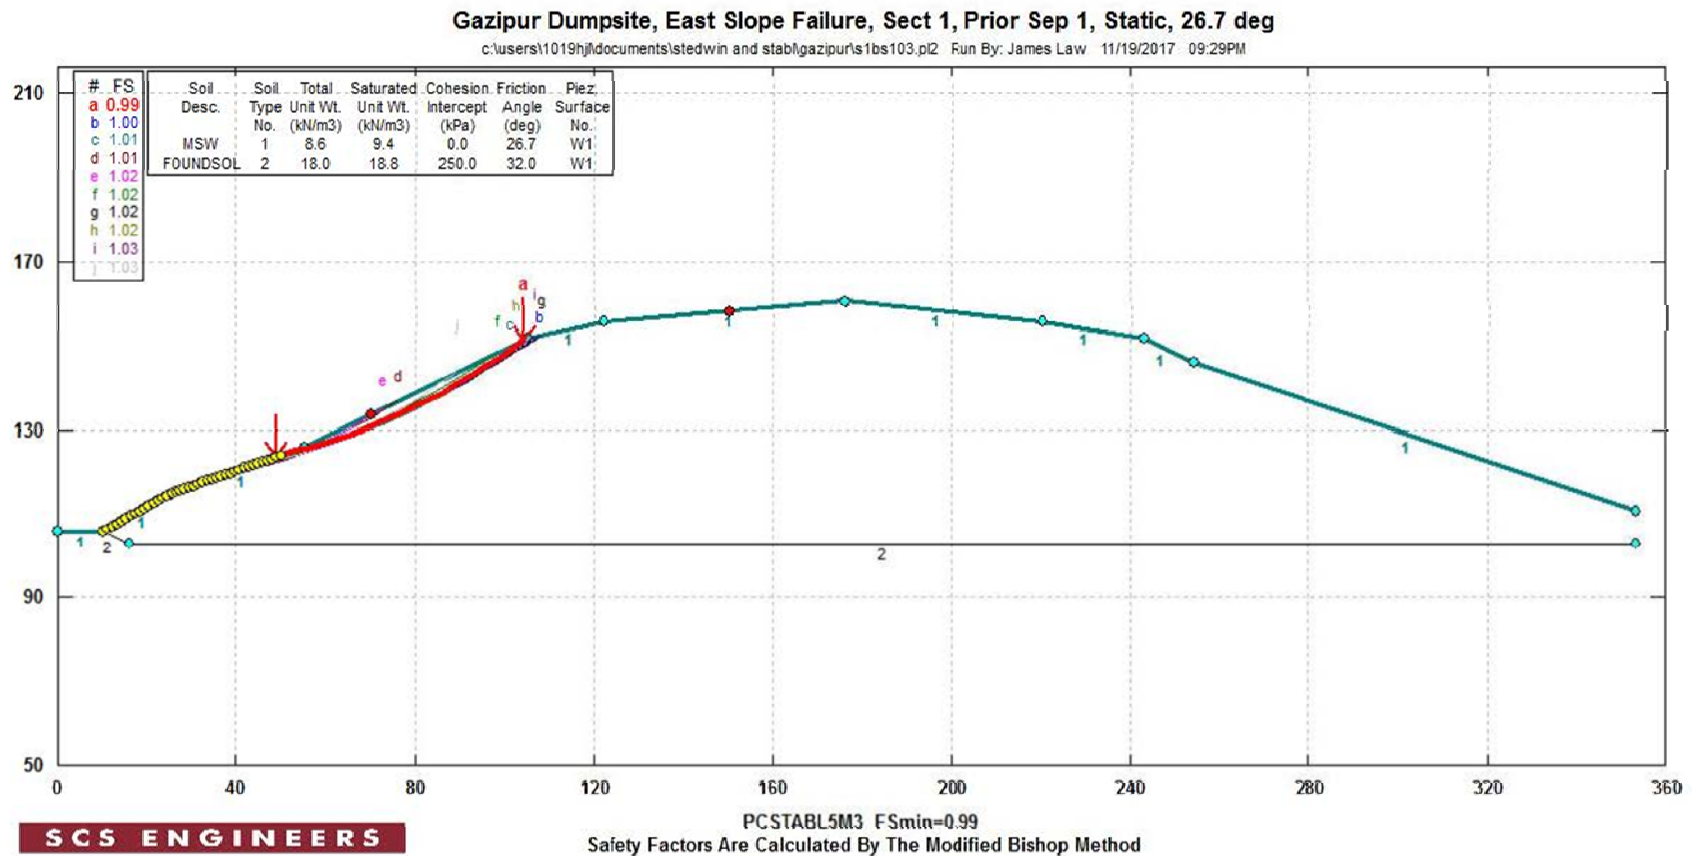
Exhibit 7. Factor of Safety at Failure at 1:1.9 Slope

The waste shear strength that results in a FS less than 1.0 (metastable condition when the slide event occurred) was back-calculated for the estimated slope ratio of 1:1.9. The estimates assume waste cohesion, C , is zero and there is no elevated liquid level within the slope area. The analysis indicated that in-place waste had a shear strength which is represented by a friction angle, ϕ , of 26.7 degrees. This value is well below the typical range of shear strength for compacted waste (32 to 35 degrees friction angle), but is typical for loose, uncompacted waste. When waste with a friction angle of 26.7 degrees is placed on a 1:1.9 slope (27.7 degrees), the probability of failure is high. In the most simple form, FS can be estimated conservatively using the "infinite slope method", where $FS = \tan(\phi) / \tan(\beta)$, where β is the slope angle.

Status	Slope (V:H)	Waste Shear Strength* (in degrees)	FS (ratio: shear strength to shear stress)
Before slope failure	1:1.9	26.7	0.99
After slope failure	1:2.1	26.7	1.04
Recommended slope	1:2.7	26.7	1.29

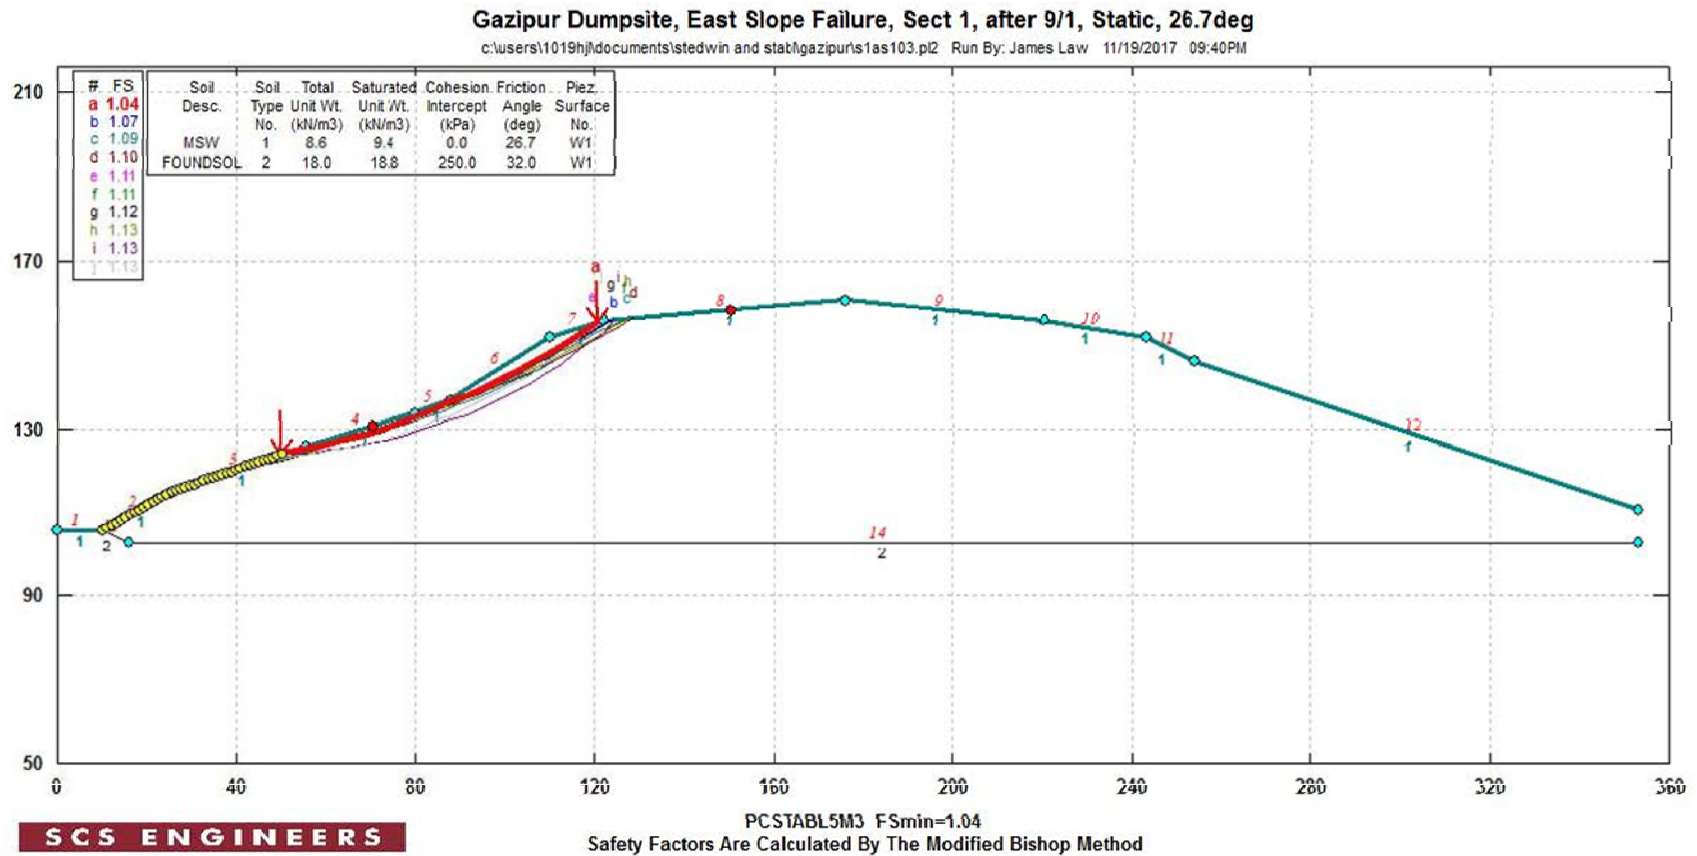
Exhibit 8. Factor of Safety after Failure at 1:2.1 Slope (Present)

The September 1, 2017 slide event moved enough material downslope and effectively moderated the slope ratio in the impacted areas to 1:2.1. While this slight slope moderation increased the FS nominally to 1.04, the slope is still considered unstable and continues to pose a significant risk of another slide event. The estimated waste friction angle of 26.7 degrees can be used to predict the slope ratio needed to achieve a minimum FS of about 1.3. Table 2 below summarizes the preliminary calculations of the FS in the area of the slope failure before and after the slide event. The table also shows that the slope needs to be reduced to 1:2.7 or less to achieve a recommended minimum FS of about 1.3.
